February 7, 2023

**Subject: Engineering Evaluation of Large Onsite Sewage System
 Clallam County Parcel # 03-30-20-58-0600
 CLM039**

United Engineering, Inc. has been retained by the Flaura's Acres POA to evaluate their Large On Site Sewage System located on E Hammond St, Belfield Ave., and Blair Ave. in Sequim. This evaluation is a system specific permit condition for the latest annual operating permit. The permit requirement asks the evaluation to address the recently reported higher than allowed average daily flow rates. Reported average daily flows were reported which exceeded the Permitted Daily Flow of 12,672 gallons per day. This report explains the how the system currently operates and evaluates how and why the daily flow amounts were reported as exceeding the Permitted Daily Flow. Recommendations on how to avoid excessive flow amounts are also included.

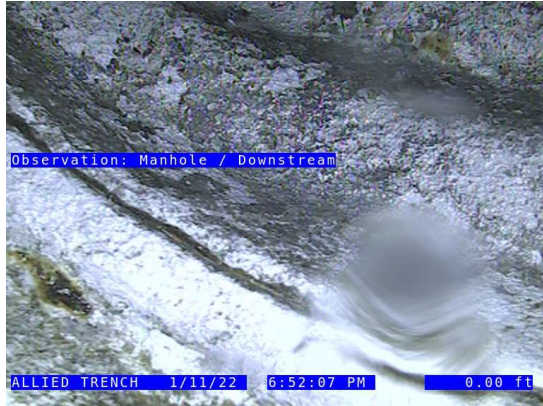
File name: **_0001.jpeg**
 Inspection date and time: **11/01/2022 18:49**
 Position: **0 ft**
 Code: **AMH**
Manhole

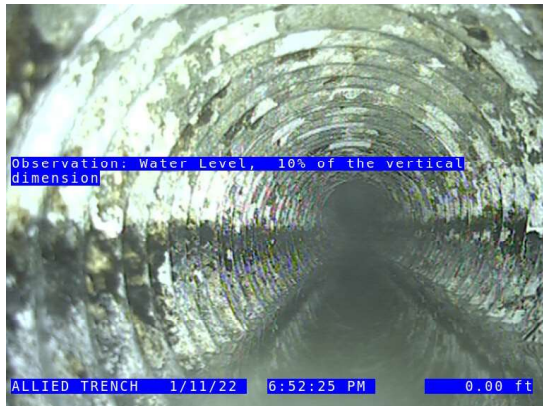
File name: **_0002.jpeg**
 Inspection date and time: **11/01/2022 18:49**
 Position: **0 ft**
 Code: **MWL**
Water Level, 10% of the vertical dimension

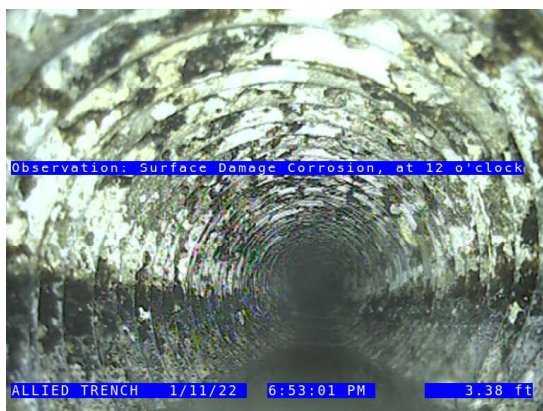
File name: **_0003.jpeg**
 Inspection date and time: **11/01/2022 18:49**
 Position: **3.38 ft**
 Code: **SCP**
Surface Damage Corrosion, at 12 o'clock

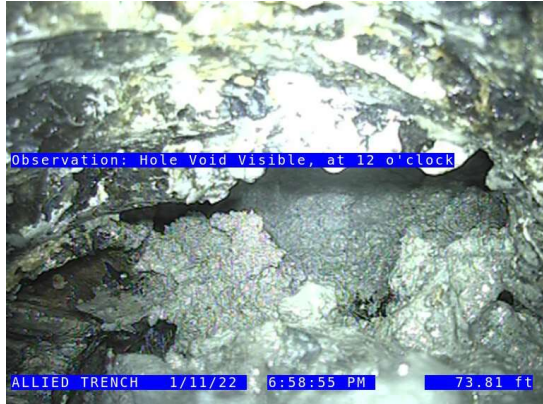
File name: **_0004.jpeg**
 Inspection date and time: **11/01/2022 18:49**
 Position: **73.80 ft**
 Code: **HVV**
Hole Void Visible, at 12 o'clock

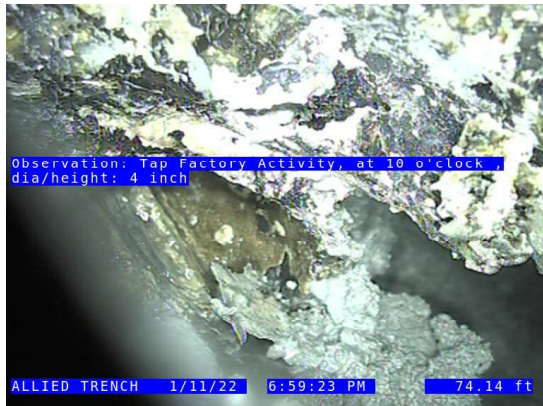
File name: **_0005.jpeg**
 Inspection date and time: **11/01/2022 18:49**
 Position: **74.14 ft**
 Code: **TFA**
Tap Factory Activity, at 10 o'clock , dia/height: 4 inch

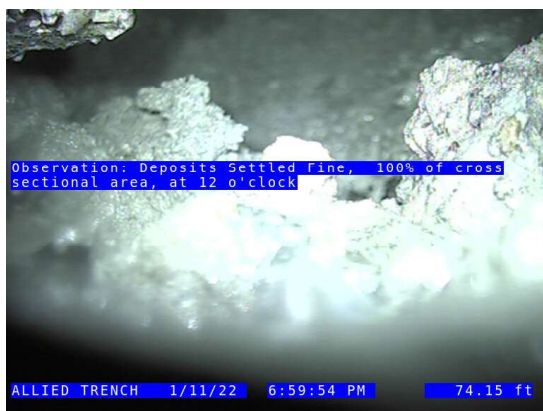
File name: **_0006.jpeg**
 Inspection date and time: **11/01/2022 18:49**
 Position: **74.15 ft**
 Code: **DSF**
Deposits Settled Fine, 100% of cross sectional area, at 12 o'clock

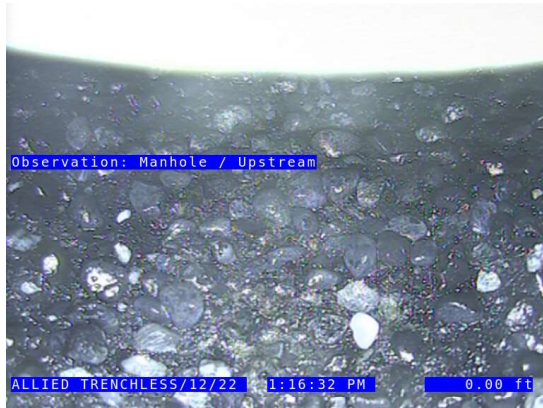
File name: **_0007.jpeg**
Inspection date and time: **12/01/2022 11:03**
Position: **0 ft**
Code: **AMH
Manhole**

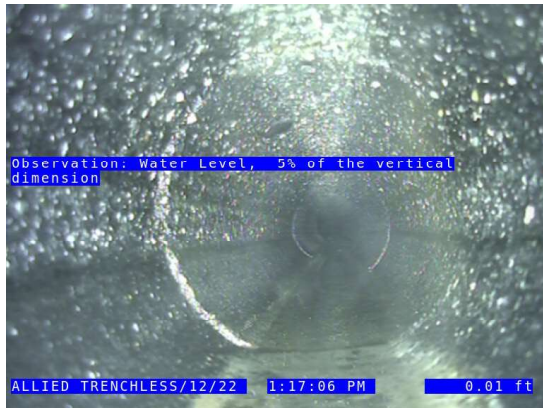
File name: **_0008.jpeg**
Inspection date and time: **12/01/2022 11:03**
Position: **0.01 ft**
Code: **MWL
Water Level, 5% of the vertical dimension**

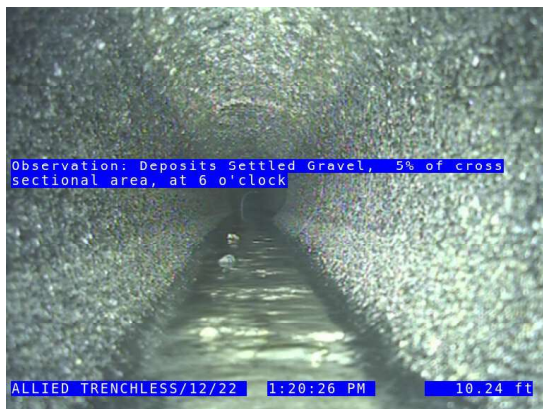
File name: **_0009.jpeg**
Inspection date and time: **12/01/2022 11:03**
Position: **10.24 ft**
Code: **DSGV
Deposits Settled Gravel, 5% of cross sectional area, at 6 o'clock**

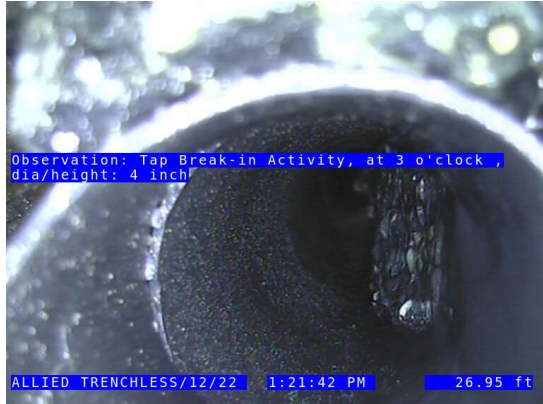
File name: **_0010.jpeg**
 Inspection date and time: **12/01/2022 11:03**
 Position: **26.95 ft**
 Code: **TBA**
**Tap Break-in Activity, at 3 o'clock ,
dia/height: 4 inch**

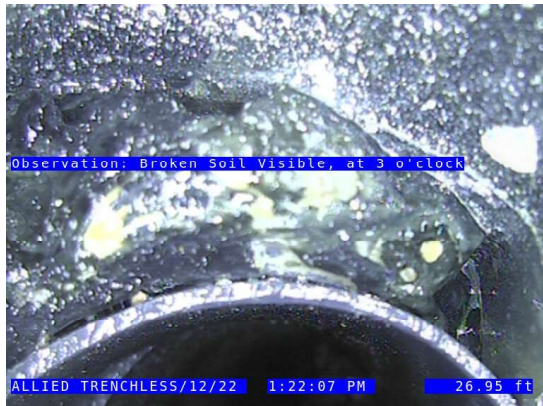
File name: **_0011.jpeg**
 Inspection date and time: **12/01/2022 11:03**
 Position: **26.95 ft**
 Code: **BSV**
Broken Soil Visible, at 3 o'clock

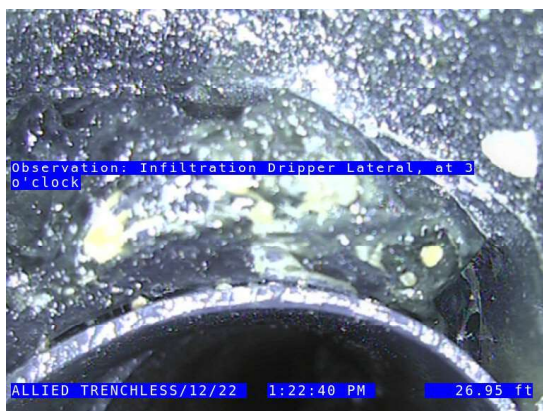
File name: **_0012.jpeg**
 Inspection date and time: **12/01/2022 11:03**
 Position: **26.95 ft**
 Code: **IDL**
Infiltration Dripper Lateral, at 3 o'clock

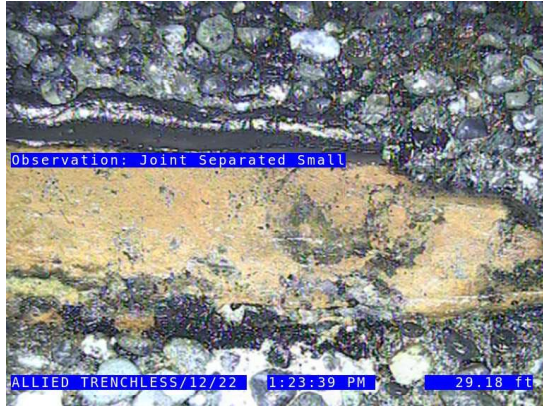
File name: **_0013.jpeg**
 Inspection date and time: **12/01/2022 11:03**
 Position: **29.18 ft**
 Code: **JSS**
Joint Separated Small

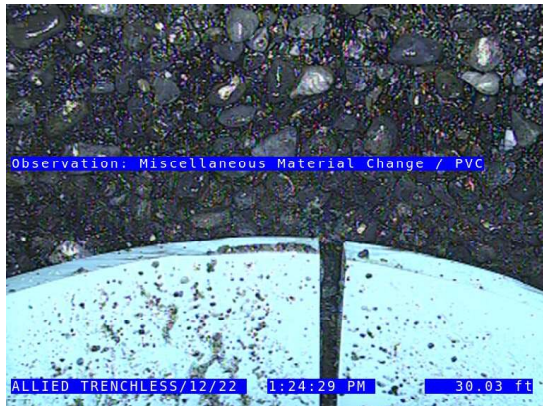
File name: **_0014.jpeg**
 Inspection date and time: **12/01/2022 11:03**
 Position: **30.03 ft**
 Code: **MMC**
Miscellaneous Material Change

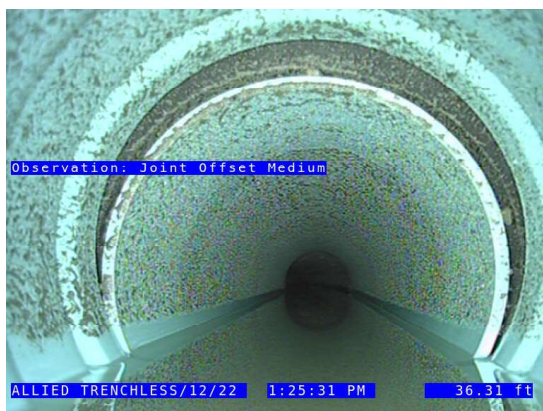
File name: **_0015.jpeg**
 Inspection date and time: **12/01/2022 11:03**
 Position: **36.31 ft**
 Code: **JOM**
Joint Offset Medium

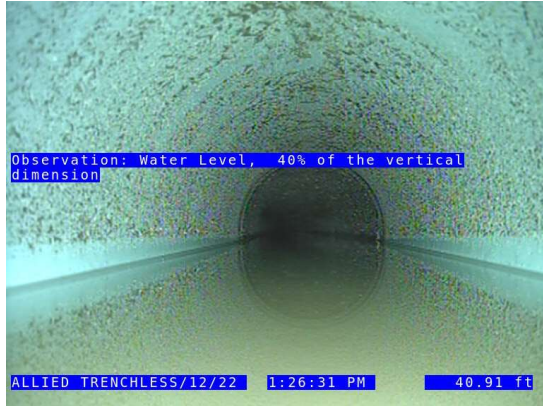
File name: **_0016.jpeg**
Inspection date and time: **12/01/2022 11:03**
Position: **40.91 ft**
Code: **MWL**
Water Level, 40% of the vertical dimension

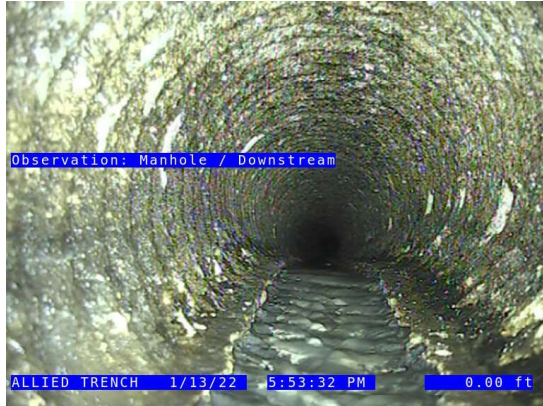
File name: **1_0001.jpeg**
 Inspection date and time: **13/01/2022 17:51**
 Position: **0 ft**
 Code: **AMH**
Manhole

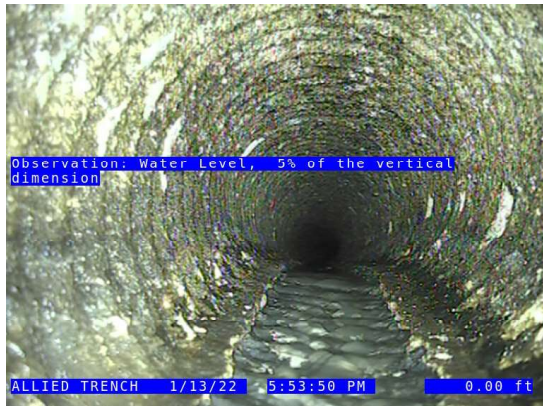
File name: **1_0002.jpeg**
 Inspection date and time: **13/01/2022 17:51**
 Position: **0 ft**
 Code: **MWL**
Water Level, 5% of the vertical dimension

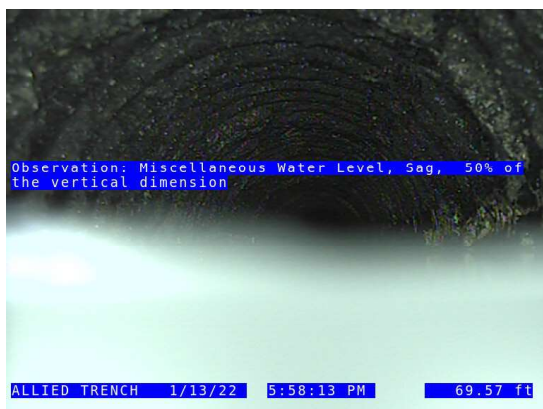
File name: **1_0003.jpeg**
 Inspection date and time: **13/01/2022 17:51**
 Position: **69.57 ft**
 Code: **MWLS**
Miscellaneous Water Level, Sag, 50% of the vertical dimension

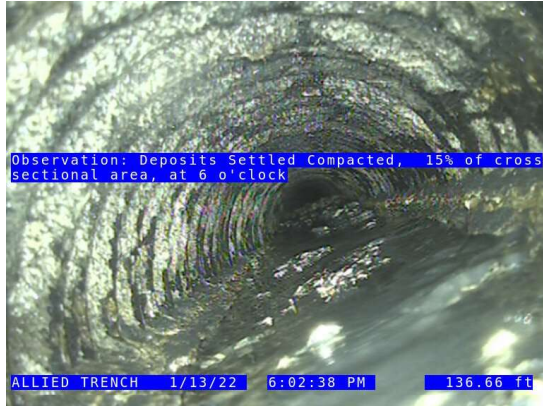
1_0004.jpeg

**Deposits Settled Compacted, 15% of
cross sectional area, at 6 o'clock**

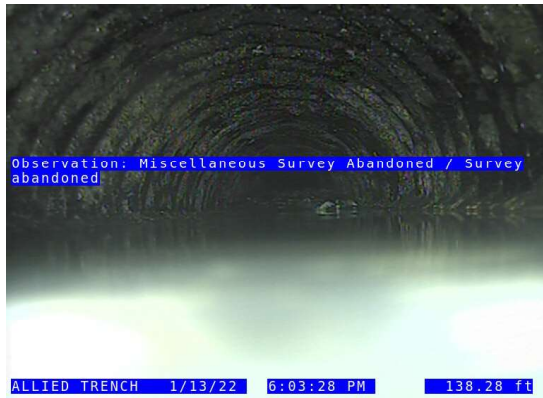
1_0005.jpeg

Miscellaneous Survey Abandoned

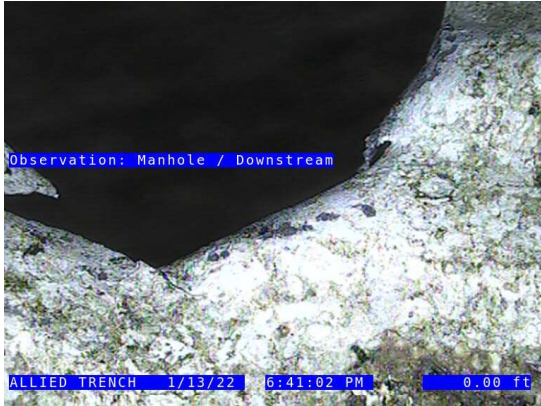
File name: **1_0006.jpeg**
 Inspection date and time: **13/01/2022 18:13**
 Position: **0.00 ft**
 Code: **AMH**
Manhole

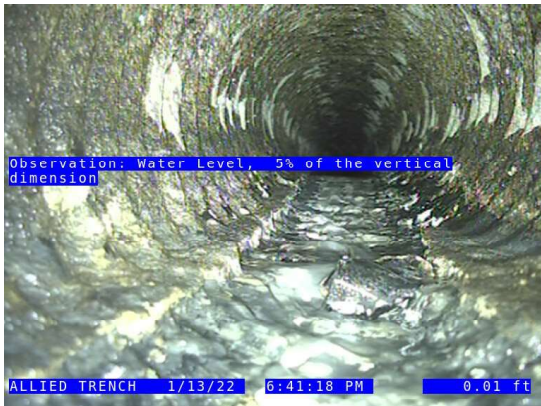
File name: **1_0007.jpeg**
 Inspection date and time: **13/01/2022 18:13**
 Position: **0.01 ft**
 Code: **MWL**
Water Level, 5% of the vertical dimension

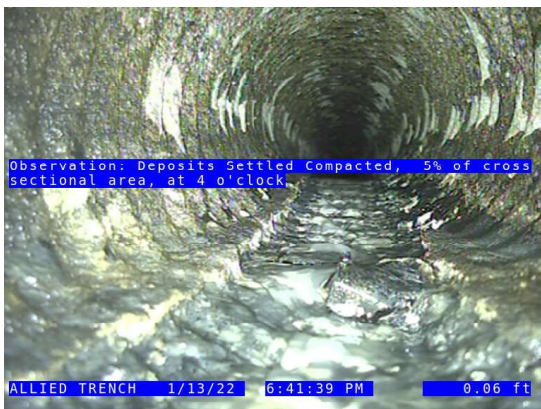
File name: **1_0008.jpeg**
 Inspection date and time: **13/01/2022 18:13**
 Position: **0.06 ft**
 Code: **DSC**
Deposits Settled Compacted, 5% of cross sectional area, at 4 o'clock

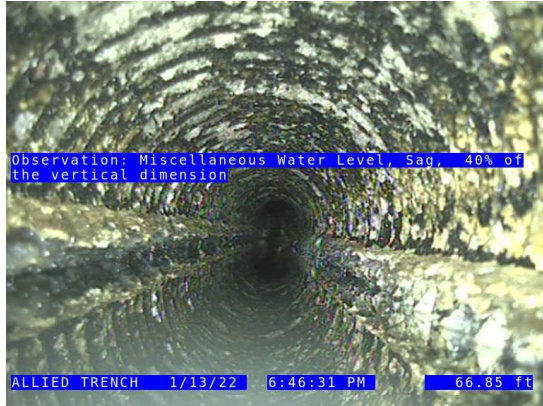
File name: **1_0009.jpeg**
 Inspection date and time: **13/01/2022 18:13**
 Position: **66.85 ft**
 Code: **MWLS**
Miscellaneous Water Level, Sag, 40% of the vertical dimension

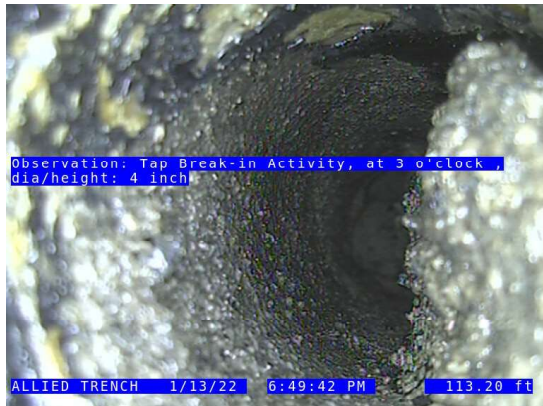
File name: **1_0010.jpeg**
 Inspection date and time: **13/01/2022 18:13**
 Position: **113.20 ft**
 Code: **TBA**
Tap Break-in Activity, at 3 o'clock , dia/height: 4 inch

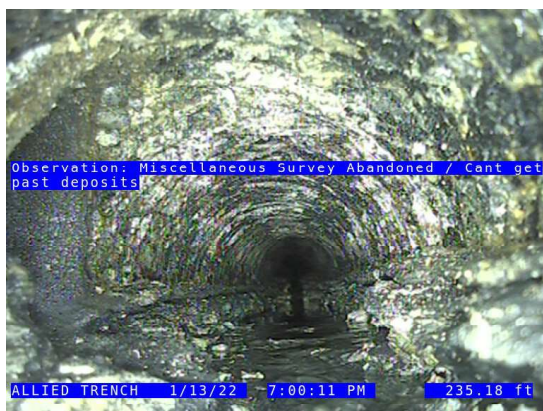
File name: **1_0011.jpeg**
 Inspection date and time: **13/01/2022 18:13**
 Position: **235.18 ft**
 Code: **MSA**
Miscellaneous Survey Abandoned

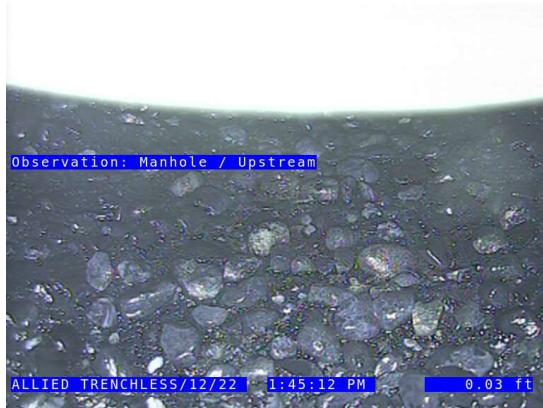
File name: **_0017.jpeg**
Inspection date and time: **12/01/2022 13:29**
Position: **0.03 ft**
Code: **AMH**
Manhole

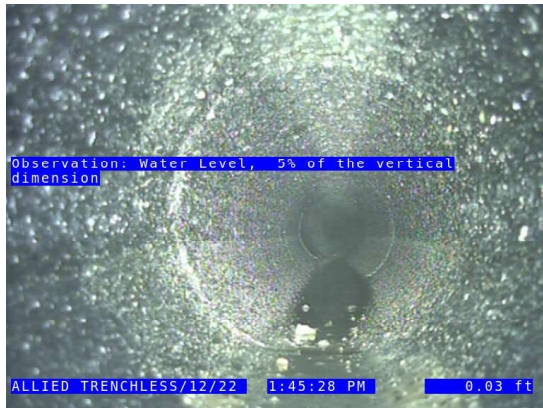
File name: **_0018.jpeg**
Inspection date and time: **12/01/2022 13:29**
Position: **0.03 ft**
Code: **MWL**
Water Level, 5% of the vertical dimension

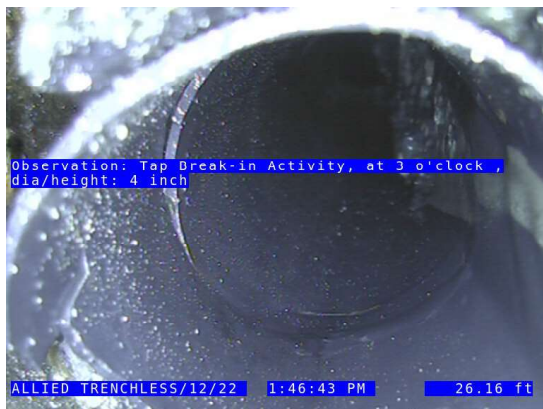
File name: **_0019.jpeg**
Inspection date and time: **12/01/2022 13:29**
Position: **26.16 ft**
Code: **TBA**
Tap Break-in Activity, at 3 o'clock , dia/height: 4 inch

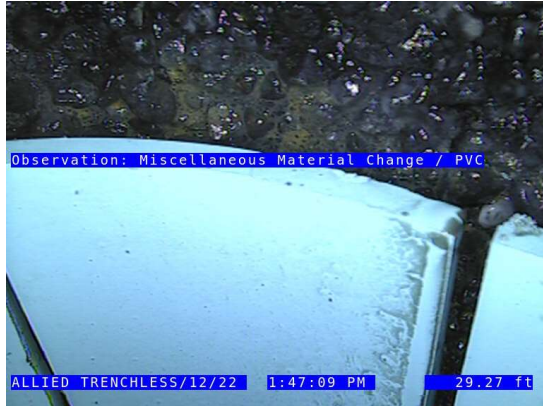
File name: **_0020.jpeg**
 Inspection date and time: **12/01/2022 13:29**
 Position: **29.27 ft**
 Code: **MMC**
Miscellaneous Material Change

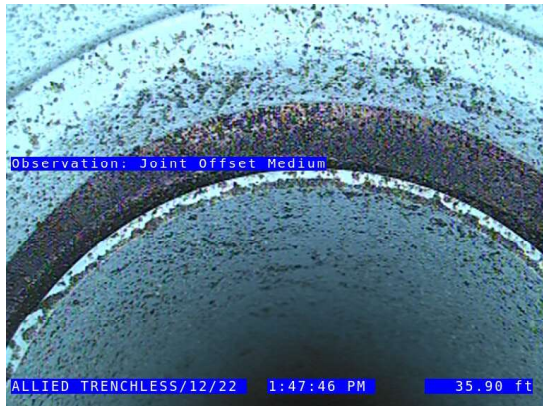
File name: **_0021.jpeg**
 Inspection date and time: **12/01/2022 13:29**
 Position: **35.90 ft**
 Code: **JOM**
Joint Offset Medium

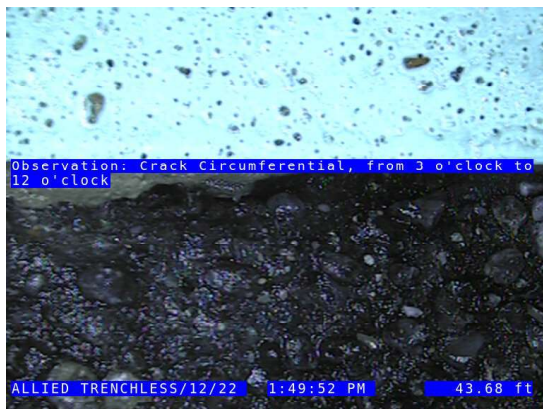
File name: **_0022.jpeg**
 Inspection date and time: **12/01/2022 13:29**
 Position: **43.68 ft**
 Code: **CC**
Crack Circumferential, from 3 o'clock to 12 o'clock

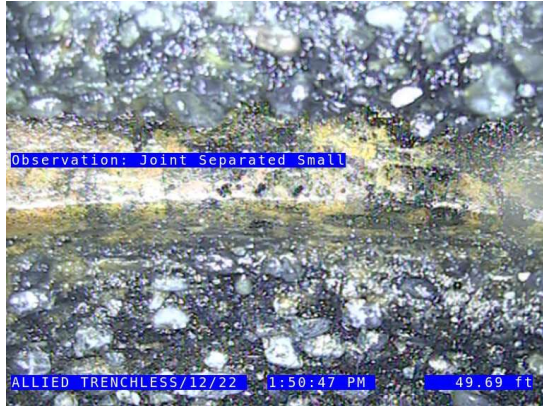
File name: **_0023.jpeg**
 Inspection date and time: **12/01/2022 13:29**
 Position: **49.69 ft**
 Code: **JSS**
Joint Separated Small

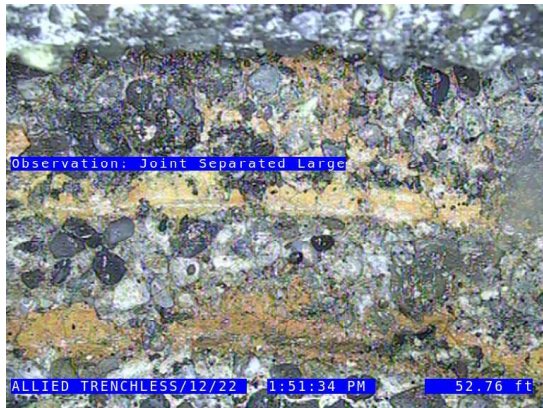
File name: **_0024.jpeg**
 Inspection date and time: **12/01/2022 13:29**
 Position: **52.76 ft**
 Code: **JSL**
Joint Separated Large

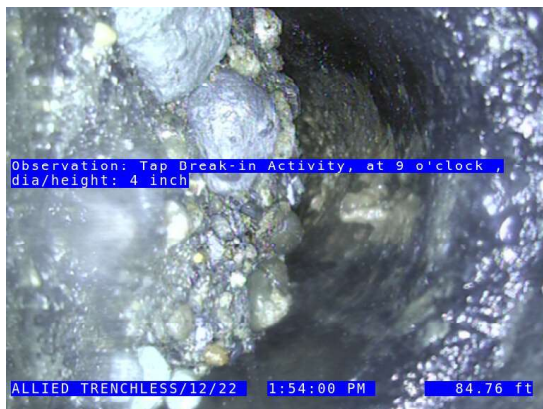
File name: **_0025.jpeg**
 Inspection date and time: **12/01/2022 13:29**
 Position: **84.76 ft**
 Code: **TBA**
Tap Break-in Activity, at 9 o'clock , dia/height: 4 inch

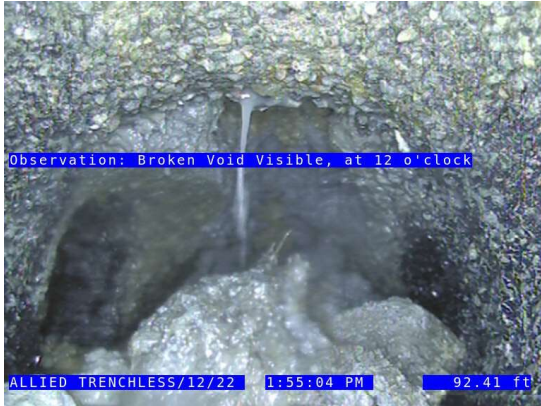
File name: **_0026.jpeg**
 Inspection date and time: **12/01/2022 13:29**
 Position: **92.41 ft**
 Code: **BVV**
Broken Void Visible, at 12 o'clock

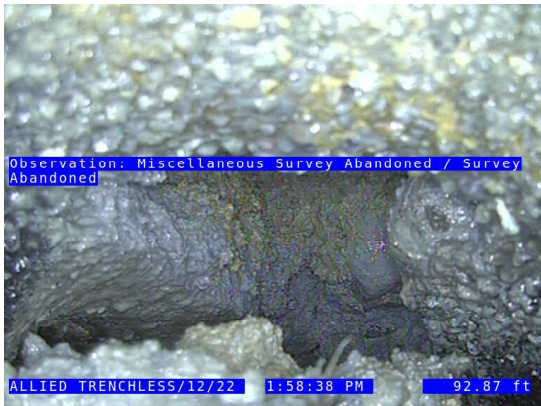
File name: **_0027.jpeg**
 Inspection date and time: **12/01/2022 13:29**
 Position: **92.87 ft**
 Code: **MSA**
Miscellaneous Survey Abandoned

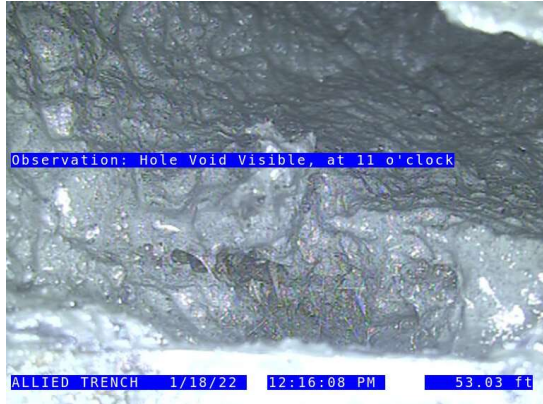
Observation: Hole Void Visible, at 11 o'clock

File name: **2_0001.jpeg**
Inspection date and time: **18/01/2022 10:48**
Position: **53.03 ft**
Code: **HVV**
Hole Void Visible, at 11 o'clock

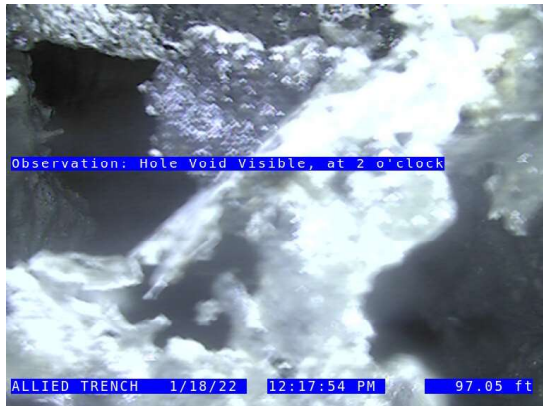
Observation: Hole Void Visible, at 2 o'clock

File name: **2_0002.jpeg**
Inspection date and time: **18/01/2022 10:48**
Position: **97.05 ft**
Code: **HVV**
Hole Void Visible, at 2 o'clock

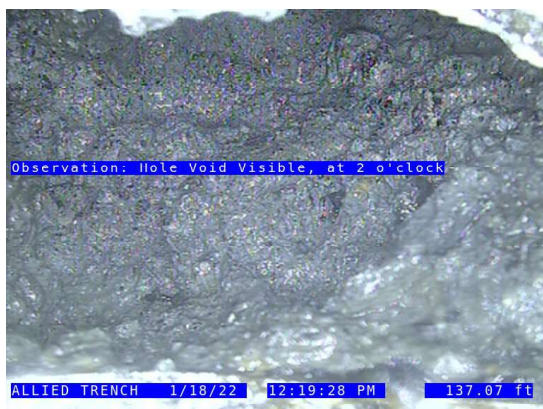
Observation: Hole Void Visible, at 2 o'clock

File name: **2_0003.jpeg**
Inspection date and time: **18/01/2022 10:48**
Position: **137.07 ft**
Code: **HVV**
Hole Void Visible, at 2 o'clock

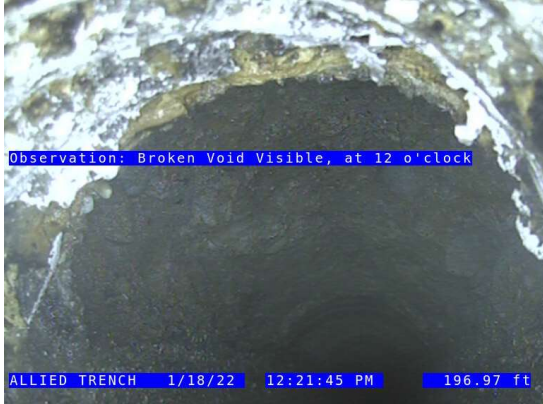
Observation: Broken Void Visible, at 12 o'clock

Broken Void Visible, at 12 o'clock

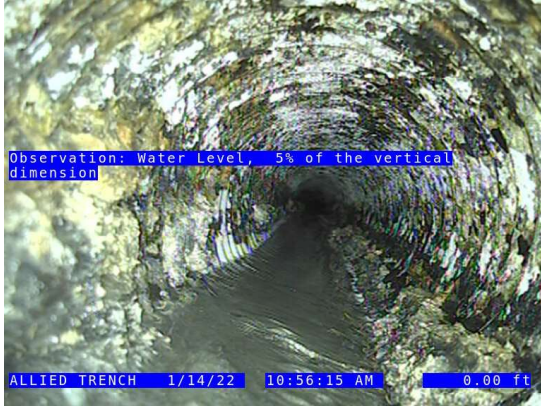
File name: **1_0012.jpeg**
 Inspection date and time: **14/01/2022 10:54**
 Position: **0 ft**
 Code: **MWL**
Water Level, 5% of the vertical dimension

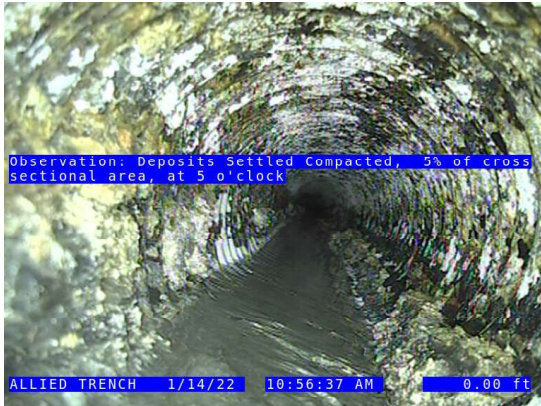
File name: **1_0013.jpeg**
 Inspection date and time: **14/01/2022 10:54**
 Position: **0 ft**
 Code: **DSC**
Deposits Settled Compacted, 5% of cross sectional area, at 5 o'clock

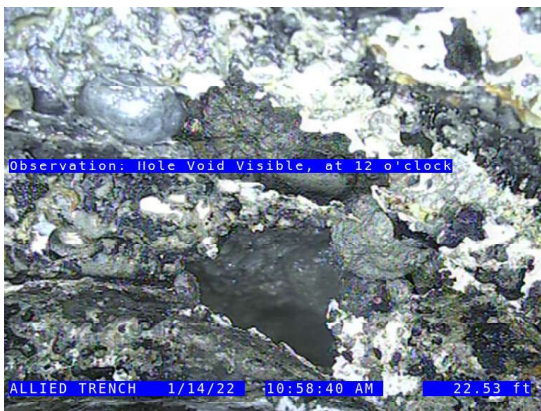
File name: **1_0014.jpeg**
 Inspection date and time: **14/01/2022 10:54**
 Position: **22.53 ft**
 Code: **HVV**
Hole Void Visible, at 12 o'clock

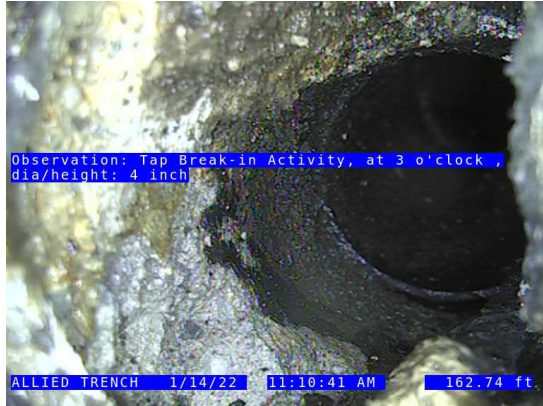
File name: **1_0015.jpeg**
 Inspection date and time: **14/01/2022 10:54**
 Position: **162.74 ft**
 Code: **TBA**
**Tap Break-in Activity, at 3 o'clock ,
dia/height: 4 inch**

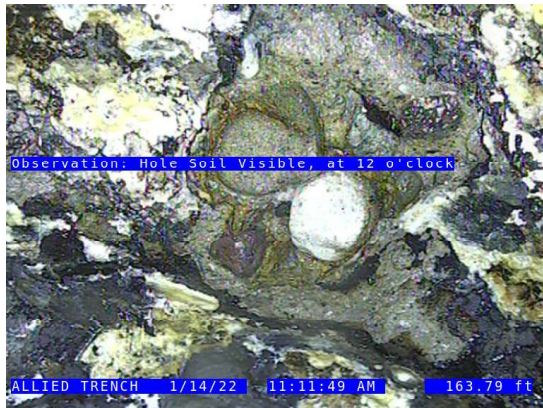
File name: **1_0016.jpeg**
 Inspection date and time: **14/01/2022 10:54**
 Position: **163.79 ft**
 Code: **HSV**
Hole Soil Visible, at 12 o'clock

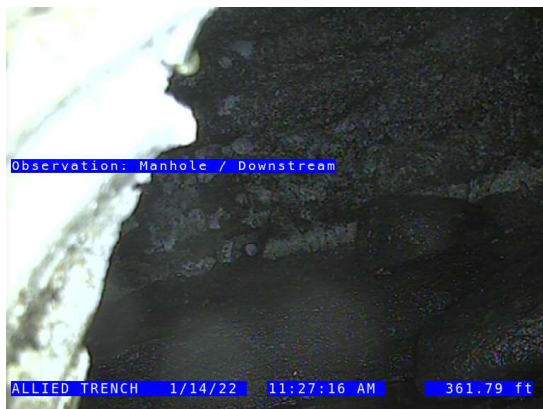
File name: **1_0017.jpeg**
 Inspection date and time: **14/01/2022 10:54**
 Position: **361.78 ft**
 Code: **AMH**
Manhole
