February 7, 2023

**Subject: Engineering Evaluation of Large Onsite Sewage System
 Clallam County Parcel # 03-30-20-58-0600
 CLM039**

United Engineering, Inc. has been retained by the Flaura's Acres POA to evaluate their Large On Site Sewage System located on E Hammond St, Belfield Ave., and Blair Ave. in Sequim. This evaluation is a system specific permit condition for the latest annual operating permit. The permit requirement asks the evaluation to address the recently reported higher than allowed average daily flow rates. Reported average daily flows were reported which exceeded the Permitted Daily Flow of 12,672 gallons per day. This report explains the how the system currently operates and evaluates how and why the daily flow amounts were reported as exceeding the Permitted Daily Flow. Recommendations on how to avoid excessive flow amounts are also included.

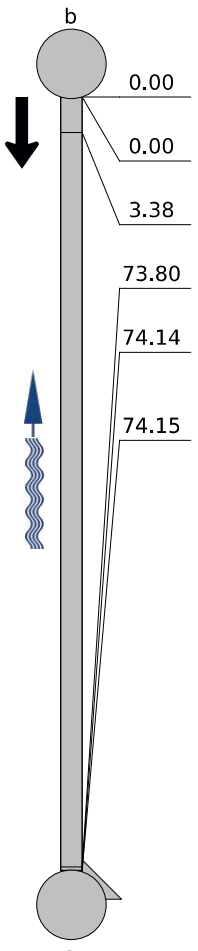
0.00		AMH	Manhole / Downstream	00:00:10	_0001.jpeg
0.00		MWL	Water Level, 10% of the vertical dimension	00:00:18	_0002.jpeg
3.38		SCP	Surface Damage Corrosion, at 12 o'clock	00:00:31	_0003.jpeg
73.80		HVV	Hole Void Visible, at 12 o'clock	00:05:46	_0004.jpeg
74.14		TFA	Tap Factory Activity, at 10 o'clock , dia/ height: 4 inch	00:05:53	_0005.jpeg
74.15		DSF	Deposits Settled Fine, 100% of cross sectional area, at 12 o'clock	00:06:01	_0006.jpeg
a

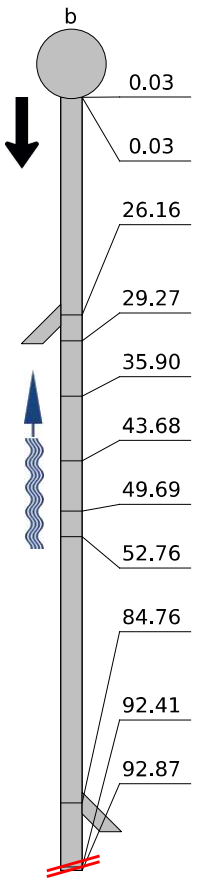
0.03		AMH	Manhole / Upstream	00:00:06	_0017.jpeg
0.03		MWL	Water Level, 5% of the vertical dimension	00:00:15	_0018.jpeg
26.16		TBA	Tap Break-in Activity, at 3 o'clock , dia/ height: 4 inch	00:01:16	_0019.jpeg
29.27		MMC	Miscellaneous Material Change / PVC	00:01:30	_0020.jpeg
35.90		JOM	Joint Offset Medium	00:01:56	_0021.jpeg
43.68		CC	Crack Circumferential, from 3 o'clock to 12 o'clock	00:03:23	_0022.jpeg
49.69		JSS	Joint Separated Small	00:04:09	_0023.jpeg
52.76		JSL	Joint Separated Large	00:04:42	_0024.jpeg
84.76		TBA	Tap Break-in Activity, at 9 o'clock , dia/ height: 4 inch	00:06:28	_0025.jpeg
92.41		BVV	Broken Void Visible, at 12 o'clock	00:07:20	_0026.jpeg
92.87		MSA	Miscellaneous Survey Abandoned / Survey Abandoned	00:10:16	_0027.jpeg

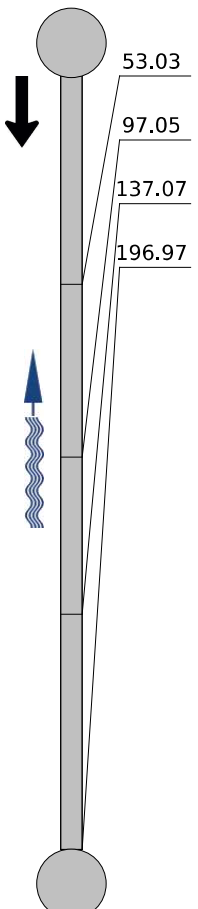
53.03		HVV	Hole Void Visible, at 11 o'clock	00:01:59	2_0001.jpeg
97.05		HVV	Hole Void Visible, at 2 o'clock	00:03:33	2_0002.jpeg
137.07		HVV	Hole Void Visible, at 2 o'clock	00:04:56	2_0003.jpeg
196.97		BVV	Broken Void Visible, at 12 o'clock	00:07:03	2_0004.jpeg

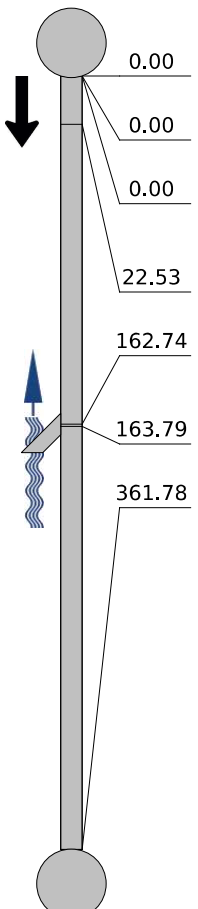
AMH	Manhole / Upstream	00:00:08	
		MWL	Water Level, 5% of the vertical dimension	00:00:15	1_0012.jpeg
		DSC	Deposits Settled Compacted, 5% of cross sectional area, at 5 o'clock	00:00:21	1_0013.jpeg
		HVV	Hole Void Visible, at 12 o'clock	00:02:11	1_0014.jpeg
		TBA	Tap Break-in Activity, at 3 o'clock , dia/ height: 4 inch	00:13:54	1_0015.jpeg
		HSV	Hole Soil Visible, at 12 o'clock	00:14:49	1_0016.jpeg
		AMH	Manhole / Downstream	00:29:28	1_0017.jpeg
